# Los Angeles Fire Department

## Greensheet

## FIREFIGHTER NEAR-MISS INCIDENT LANKERSHIM STRUCTURE FIRE

January 7, 2008

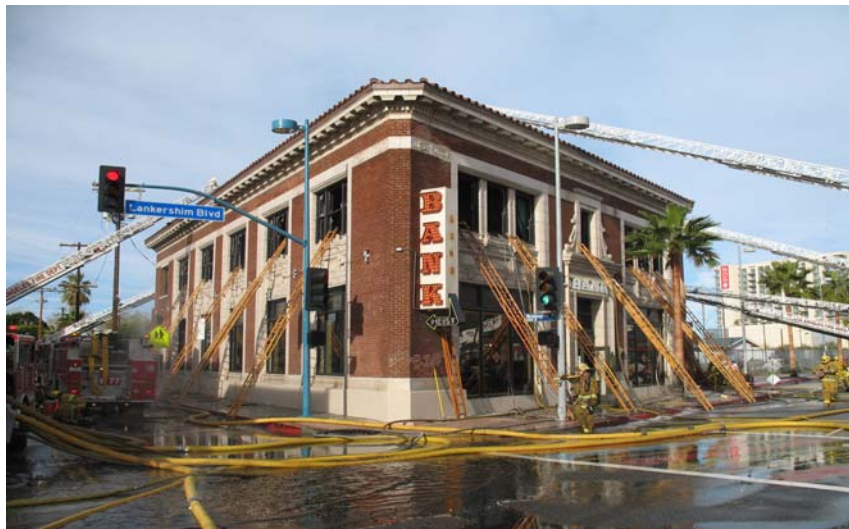
The fire building was a 2 story brick and heavy timber structure built in 1926 as a commercial bank building. The 53’ (A) x 110’ (B) x 60’ (C) x 73’ (D) building was located on the North West corner of Lankershim Boulevard and Weddington Street in the community of North Hollywood. The building had just completed a significant remodel and occupancy type change to include a restaurant and bar on the first floor with a nightclub and dance area on the second floor.

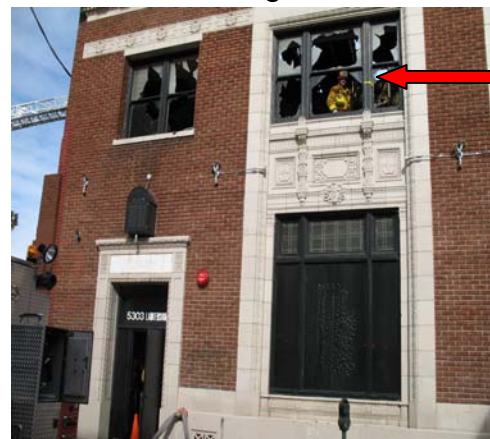
Instead of reaching the stairwell, the Nozzle member from Engine 76 struck a wall, started

to move along the wall and ran out of air. He attempted to depress the Emergency Trigger button on his radio, but was unable to do so due to his large, wet gloves. He removed his right glove and attempted to depress the button a second time, and was once again unable to do so. He followed the wall looking for an exit and states that he saw light and headed in that direction. Upon reaching the light, he broke out the window with his pick headed axe. He removed his helmet and utilized it to signal for help out the window. This window is located on the "B" side near the "B / C" corner of the building.
