TRAINING BULLETIN NO. 25
PROBLEMS ENCOUNTERED IN GYMNASIUM FLOOR FIRES
MAY 1979

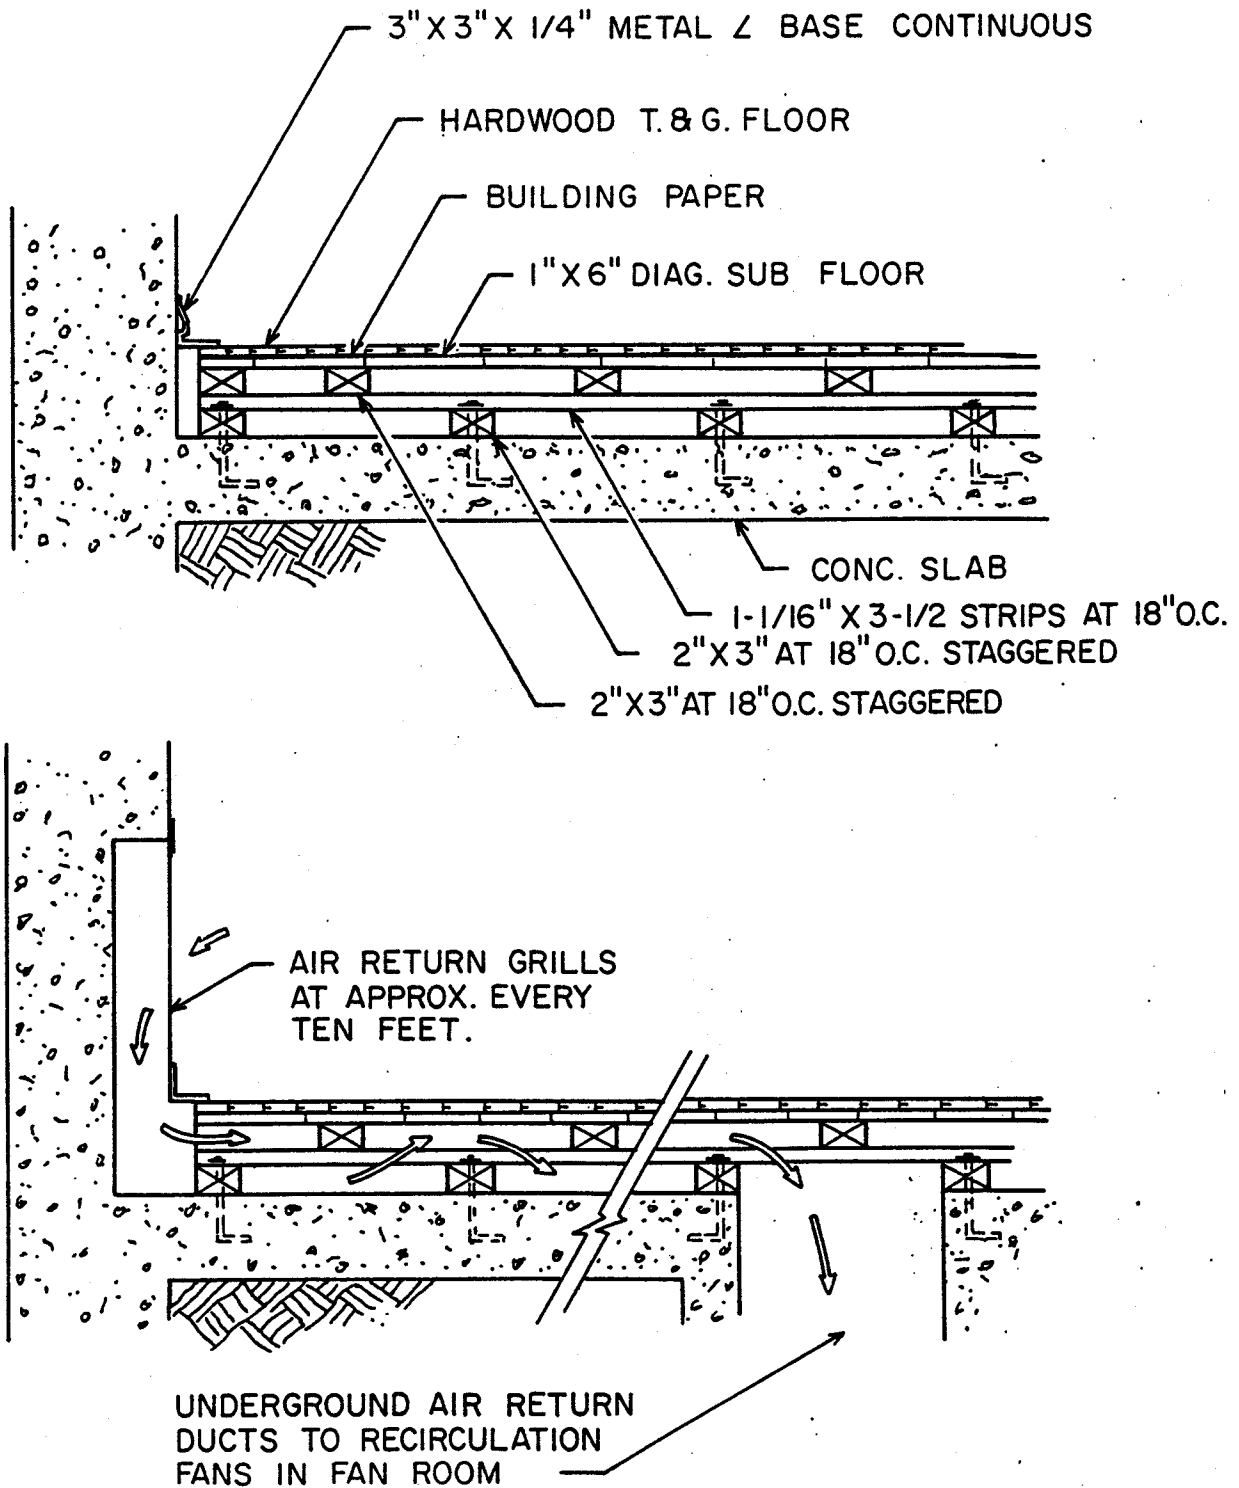
Figure 1

These floors are constructed of tongue and groove hardwood, built up off of concrete on cross-laid strips to allow for ventilation under the floor. In essence, the floor is free floating, with a metal angle sealing it to the wall. (See Figure 1.)

TYPICAL GYMNASIUM FLOOR CONSTRUCTION
